# The Geological Survey and Resource Assessment Division

**Department of Natural Resources**

Cameron, Missouri  
Water supply Study  
Assuming the GLM Site A 2 to be raised three feet.

To Determine effects of raising available storage in the GLM reservoir three feet.

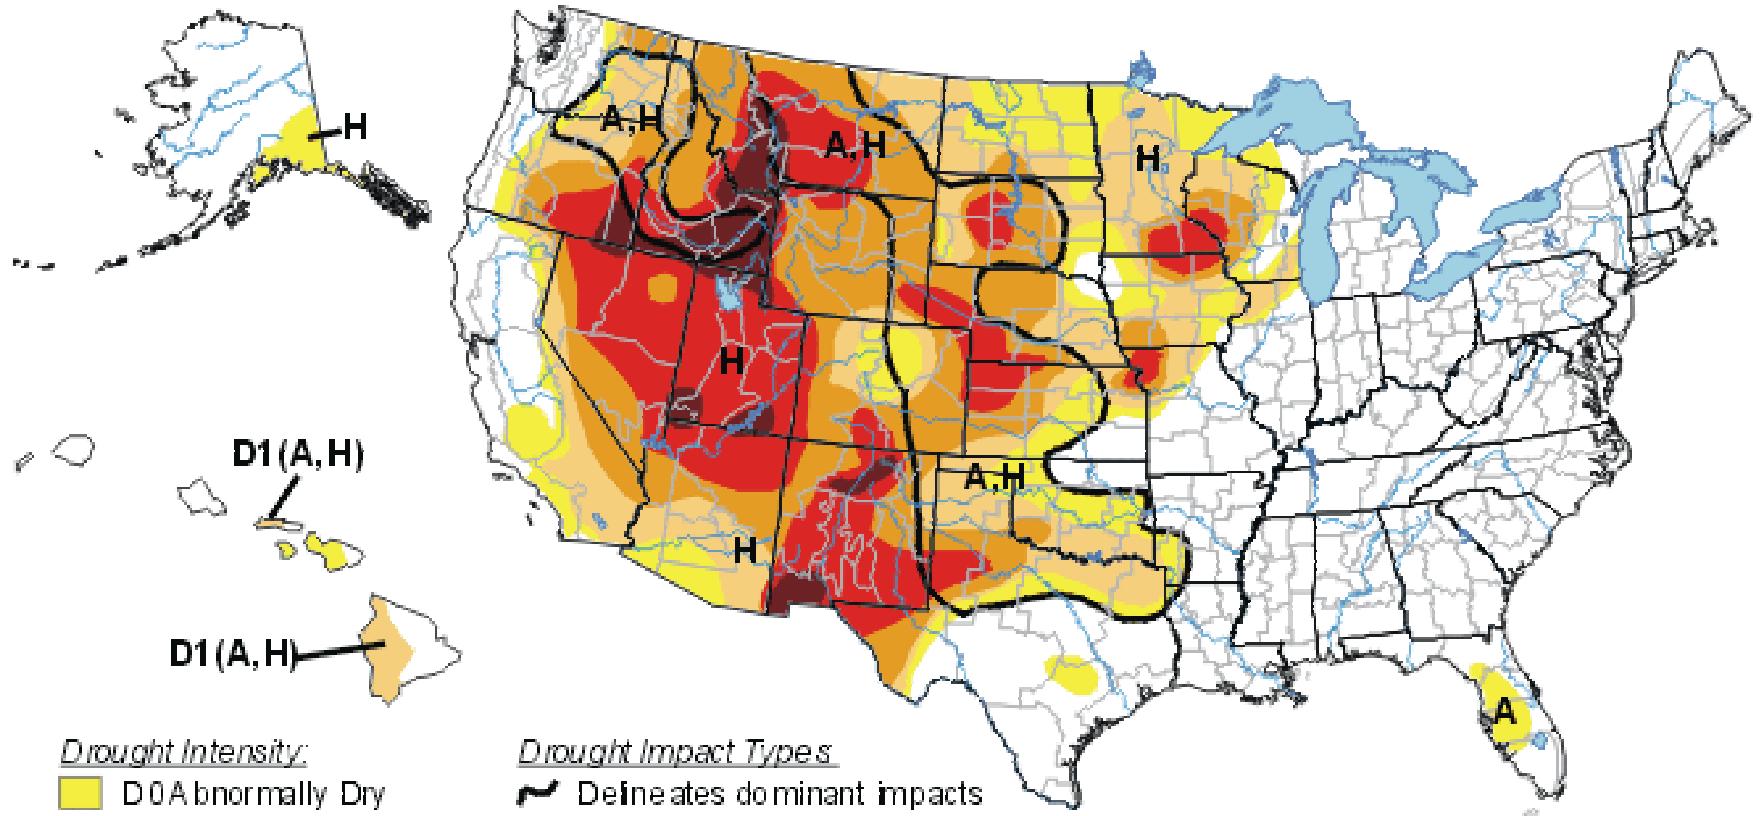
# U.S. Drought Monitor

- [Yellow square] D0 Abnormally Dry
- [Orange square] D1 Drought - Moderate
- [Dark Orange square] D2 Drought - Severe
- [Red square] D3 Drought - Extreme
- [Dark Red square] D4 Drought - Exceptional

- [Wavy line symbol] Defineates dominant impacts
- A = Agricultural (crops, pastures, grasslands)
- H = Hydrological (water)
- (No type = Both impacts)

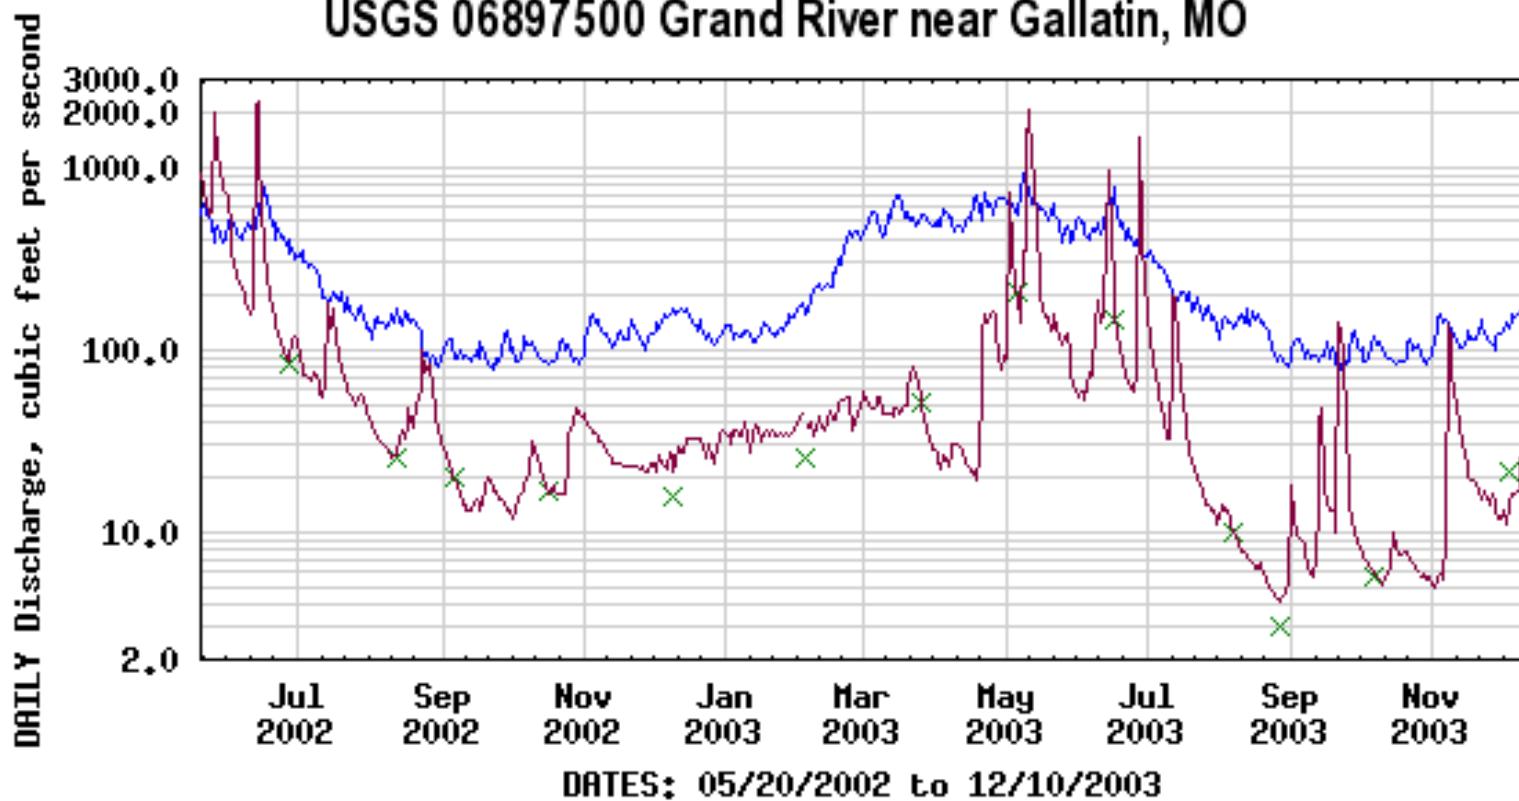
## USGS 06897500 Grand River near Gallatin, MO

- MEDIAN DAILY STREAMFLOW BASED ON 82 YEARS OF RECORD
- × MEASURED Discharge
- DAILY MEAN DISCHARGE

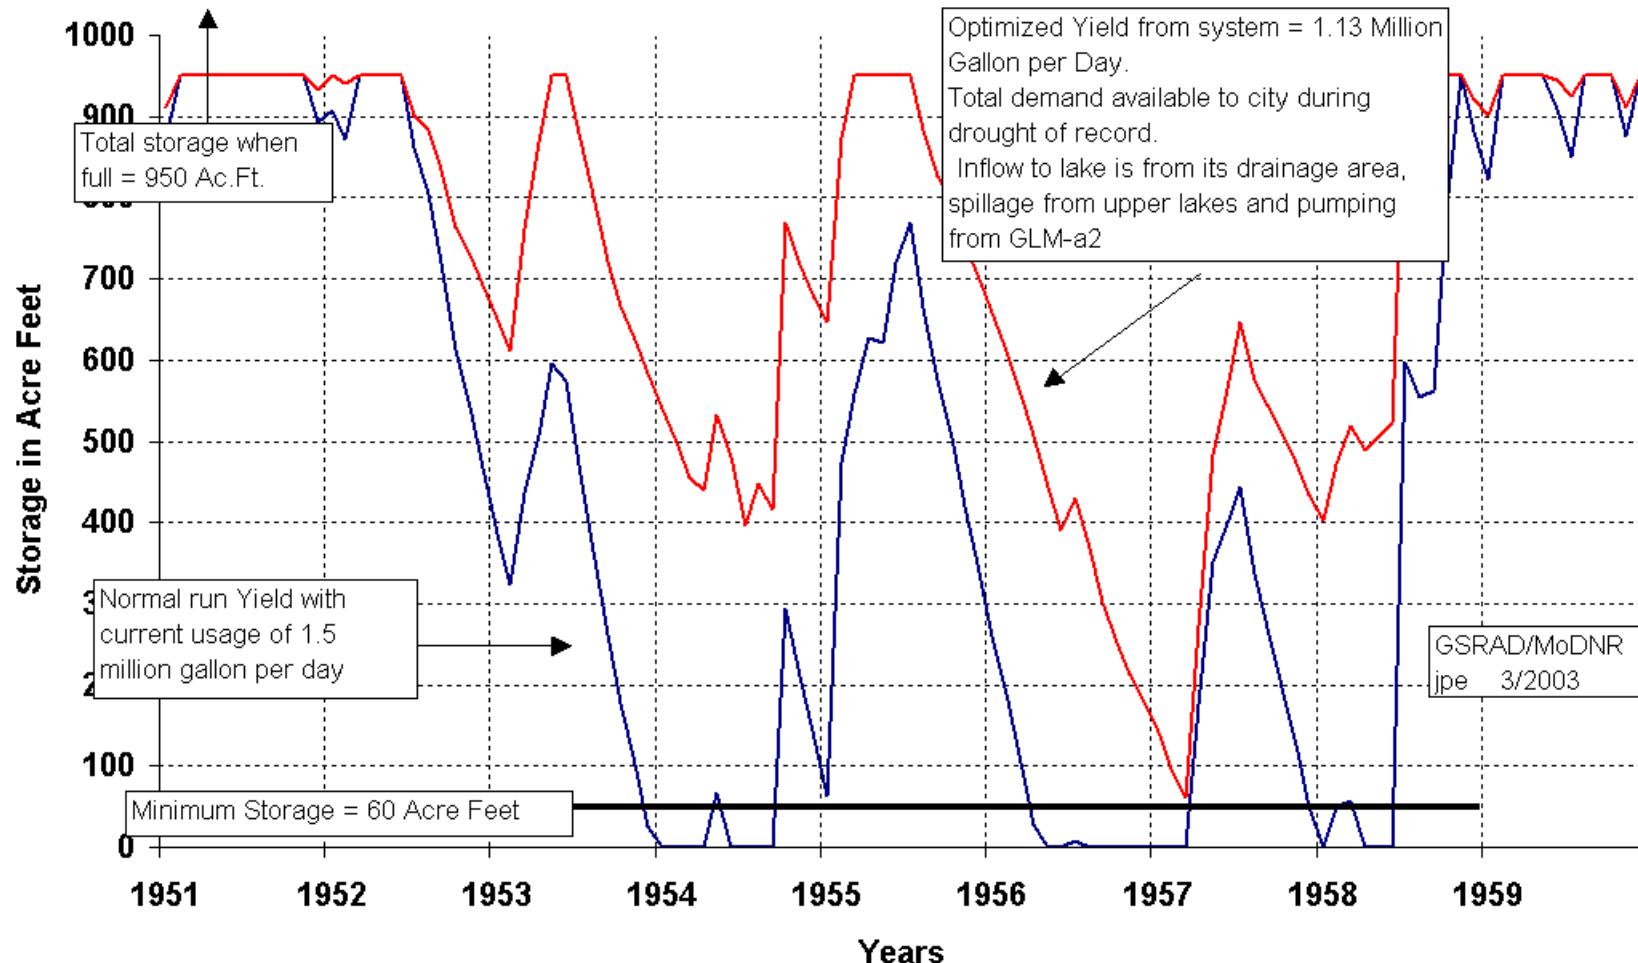
Lake Number 3

Reservoir analysis during the 1950's Drought  
Missouri Water Supply Analysis

Cameron - GLM Raised 3 feet

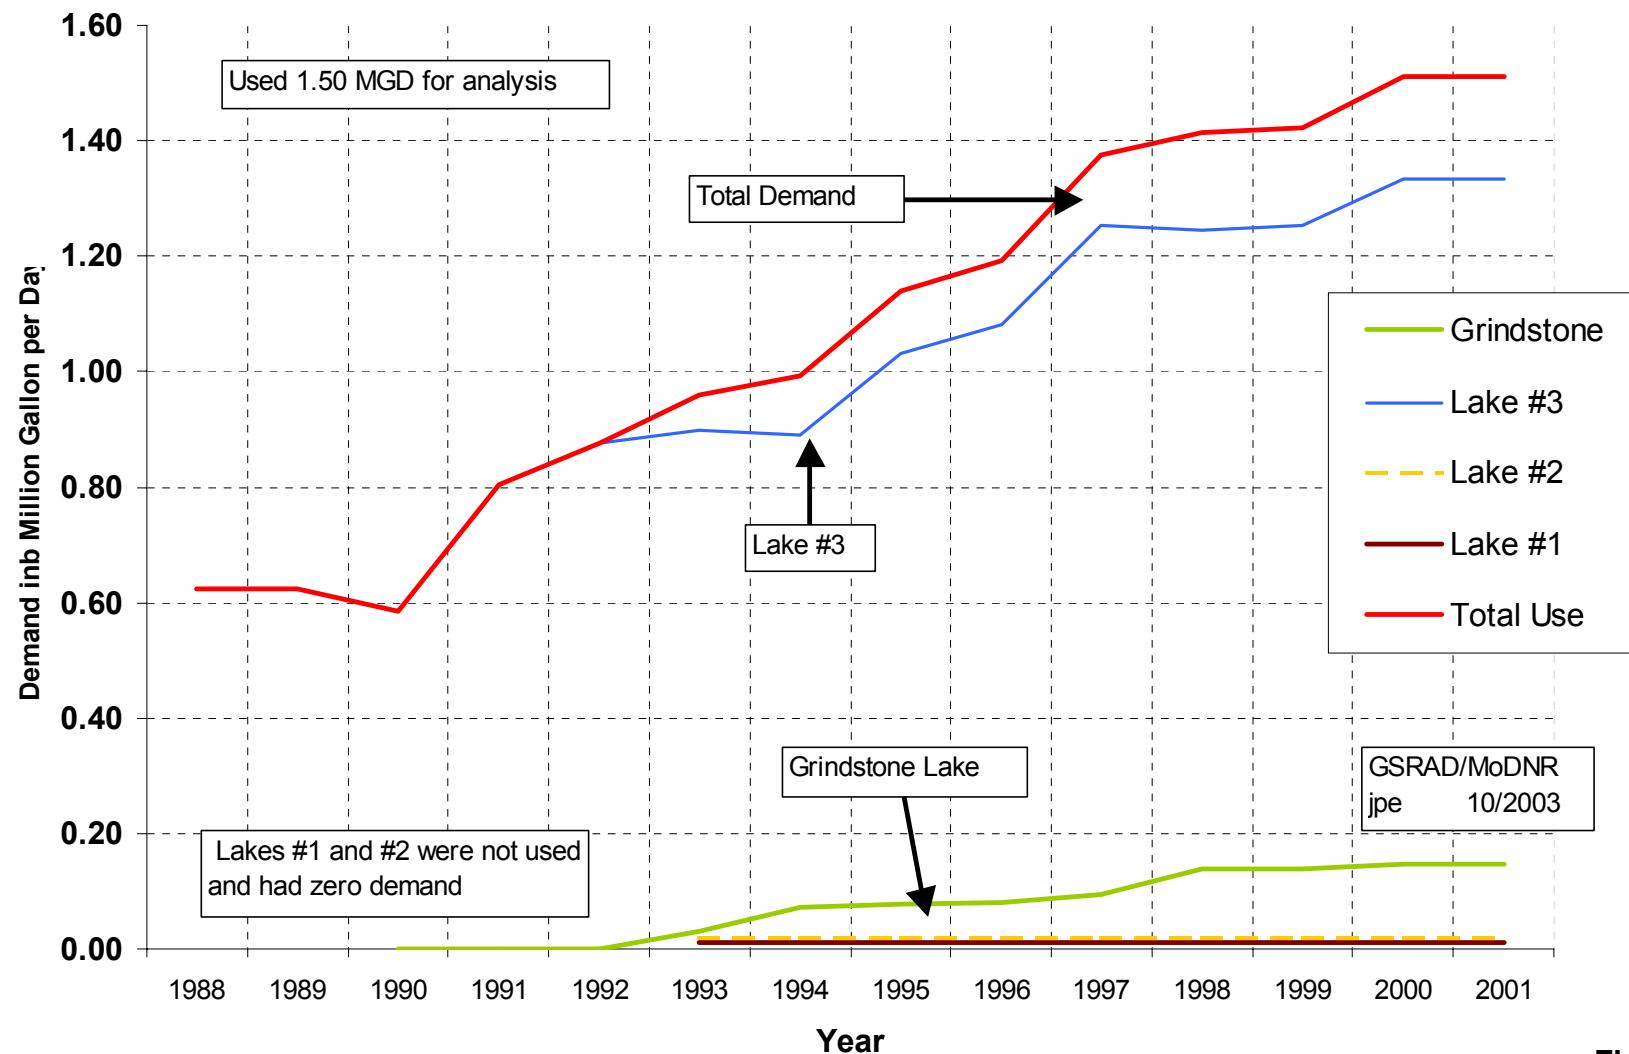
Figure

Fn = Water Use Hist

### Demand in Million Gallon per Day

The average daily demand of 1.5 MGD was used.  
See file "Historical Water use.xls" (Figure 1)

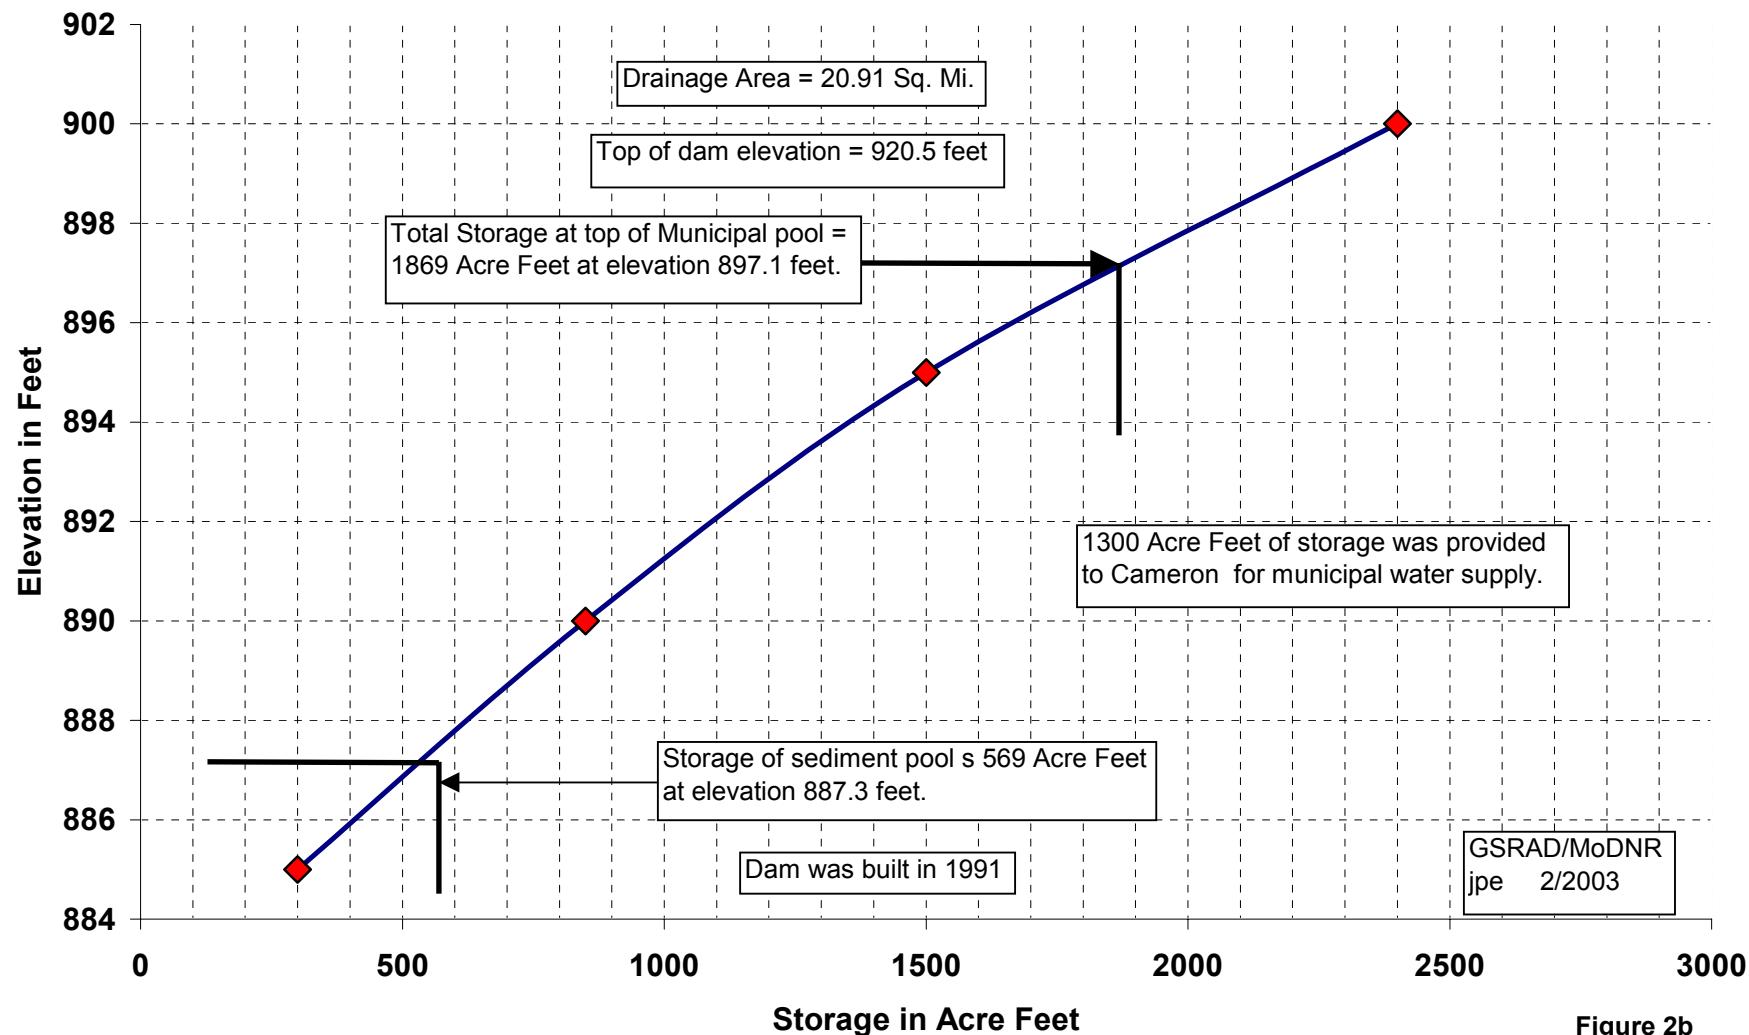
Figure 2b

**Cameron, Missouri**  
**Water supply analysis**  
**Grindstone Lost Muddy Watershed Site A2**

fn = Stor-GLM-A2.xls(Stor Low)

Storage data is shown in figures 2a and 2b. Figure 2a shows the storage to the top of Grindstone dam and 2b shows storage up to the proposed municipal pool. There was no change to Reservoir Number 3. See files: "GLM-A2-Stor.xls(Stor)" for figure 2a.  
"GLM-A2-Stor.xls(Low Stor)" for figure 2b.  
"Stor-3lakes.xls(Res#3 Stor)" for figure 3.

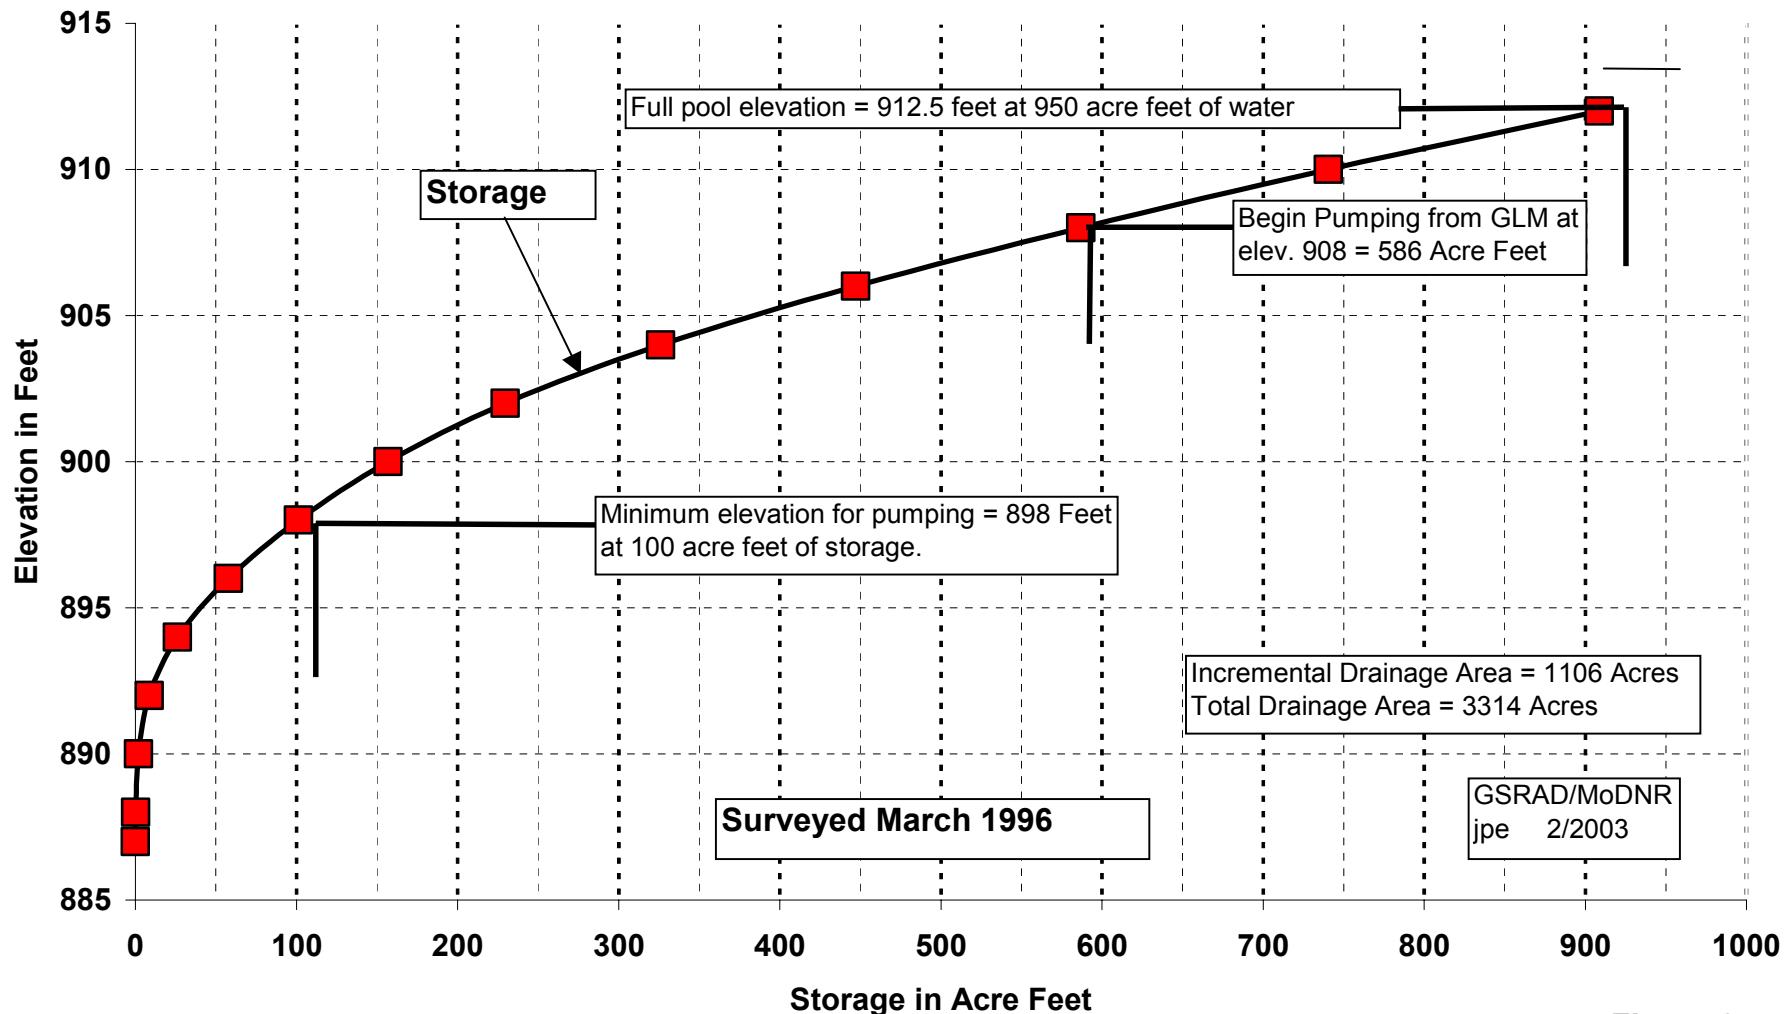
**Figure 3**

**Cameron, Missouri**  
Reservoir No. 3  
Location - SE, SE, NE Sec. 9, T57N, R30W  
Weir Elevation = 912.5

Fn = Stor-3lakes.xls(Res#3 Stor)

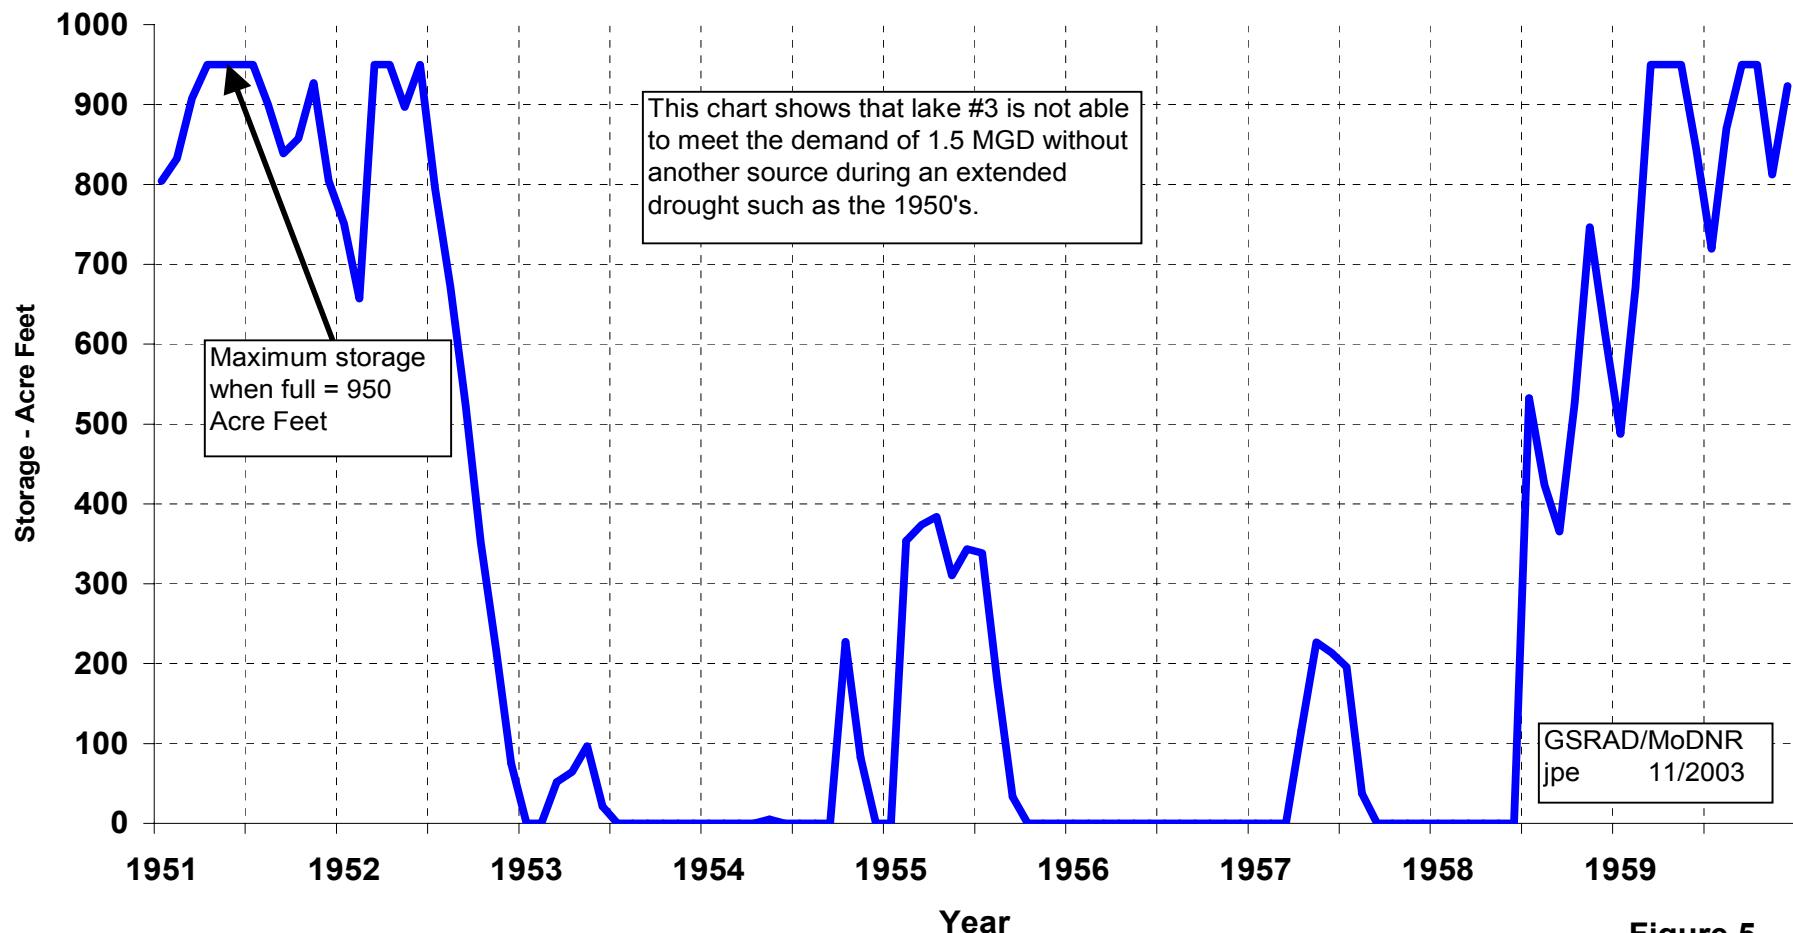
No Inflow from GLM

Demand of 1.5 MGD being met by this lake only

Figure 5 is remaining storage in lake #3, assuming that all the 1.5 MGD demand comes from this lake. Results show that demand could never be met. See file "Old Lake #3.xls"

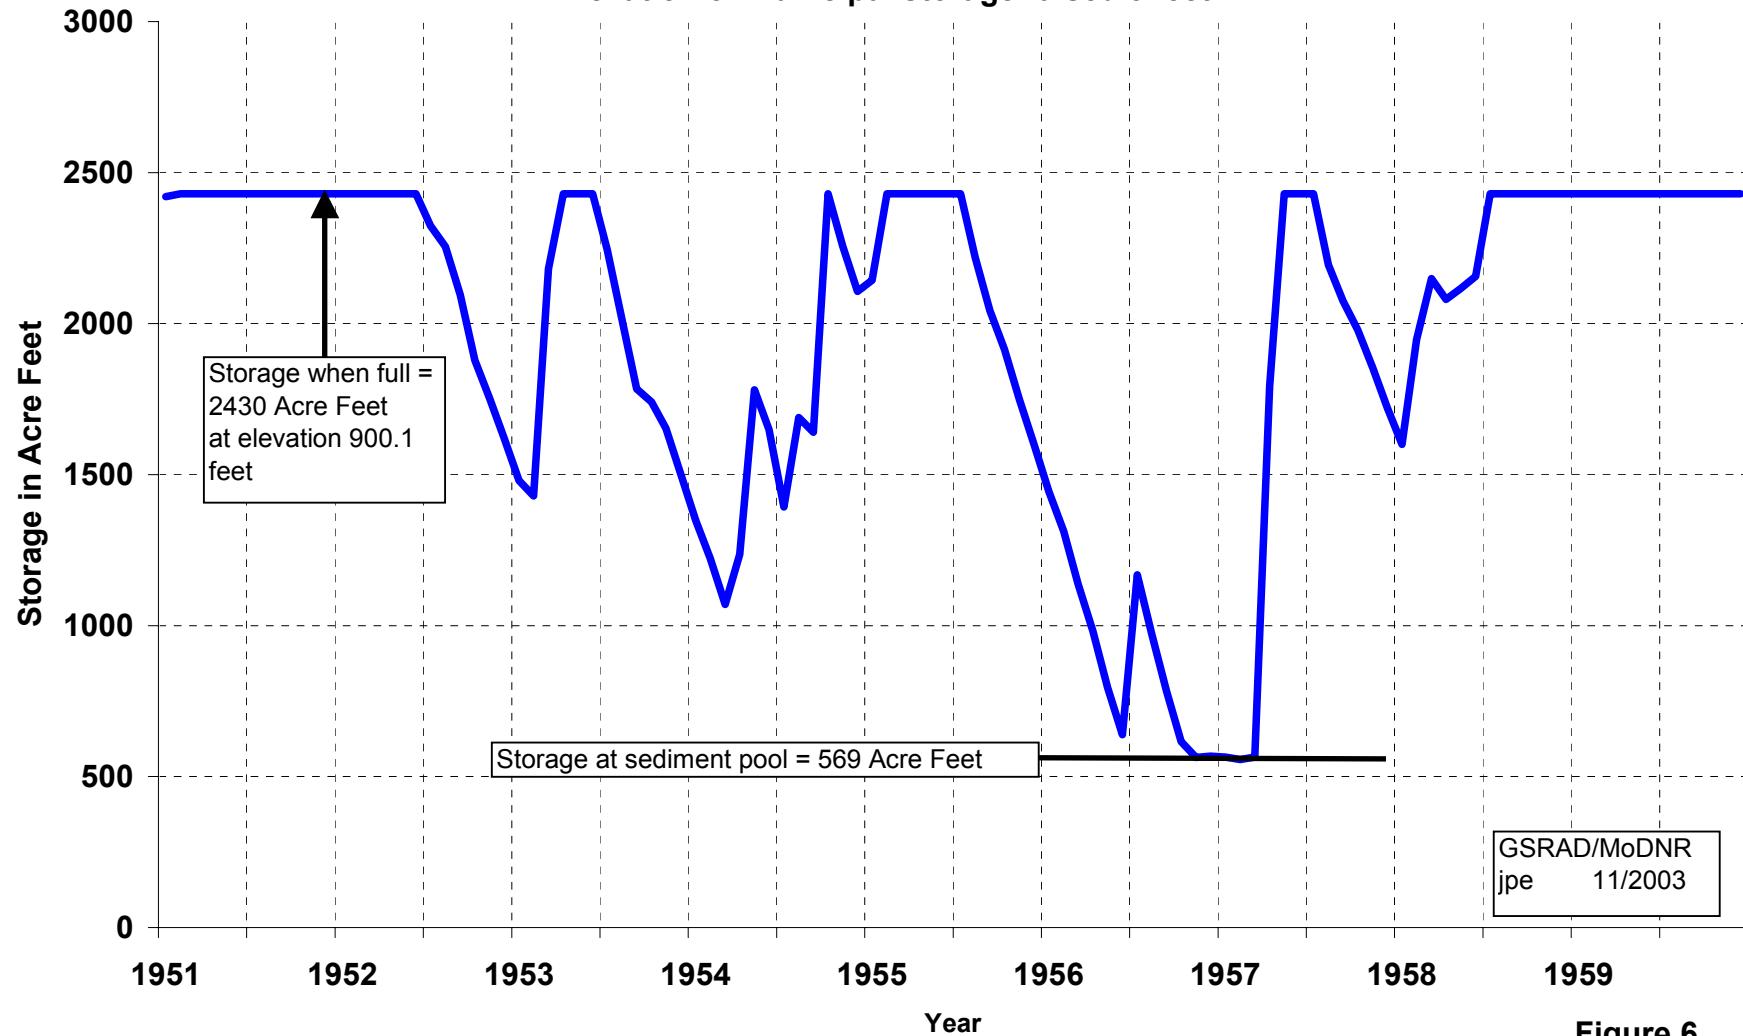
GLM site A-2

Elevation of municipal storage raised 3 feet

Figure 6 Is the analysis of Grindstone Lake supplying water to lake #3 with one 1000 GPM pump to keep the water level in lake #3 near full. Annual pumped volume from Grindstone Lake for this analysis is:

1951 ... 0. Acre Feet  
1952 ... 775. Acre Feet  
1953 ... 1013. Acre Feet  
1954 ... 1610. Acre Feet  
1955 ... 812. Acre Feet  
1956 ... 1391. Acre Feet  
1957 ... 812. Acre Feet  
1958 ... 949. Acre Feet  
1959 ... 0. Acre Feet

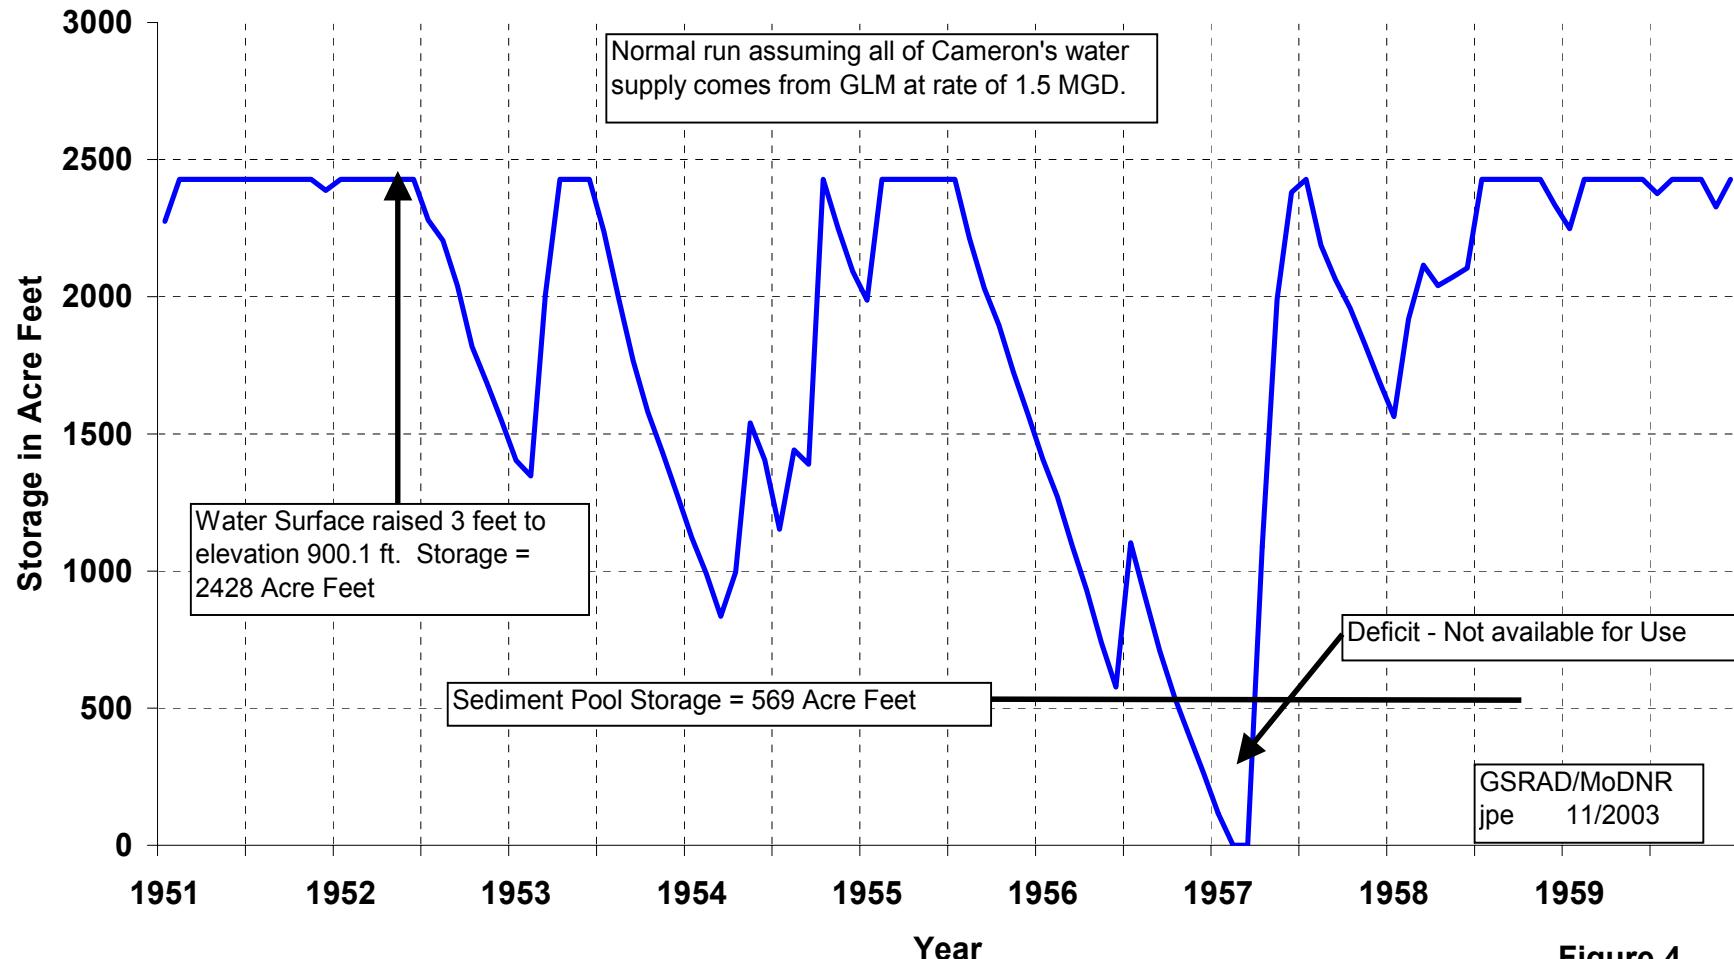
**Cameron, Missouri**  
**Grindstone Lost Muddy Site A2**  
**Normal Run**  
**Supplying 1.5 MGD**  
**Water Supply storage raised 3 feet**

Figure 4 shows the storage after the RESOP analysis in Grindstone Lake. This analysis assumes that the entire demand of 1.5 MGD comes from this lake. The result shows that this lake alone could not sustain 1.5 MGD in late 1956 and early 1957. See File "GLM-norm.xls"

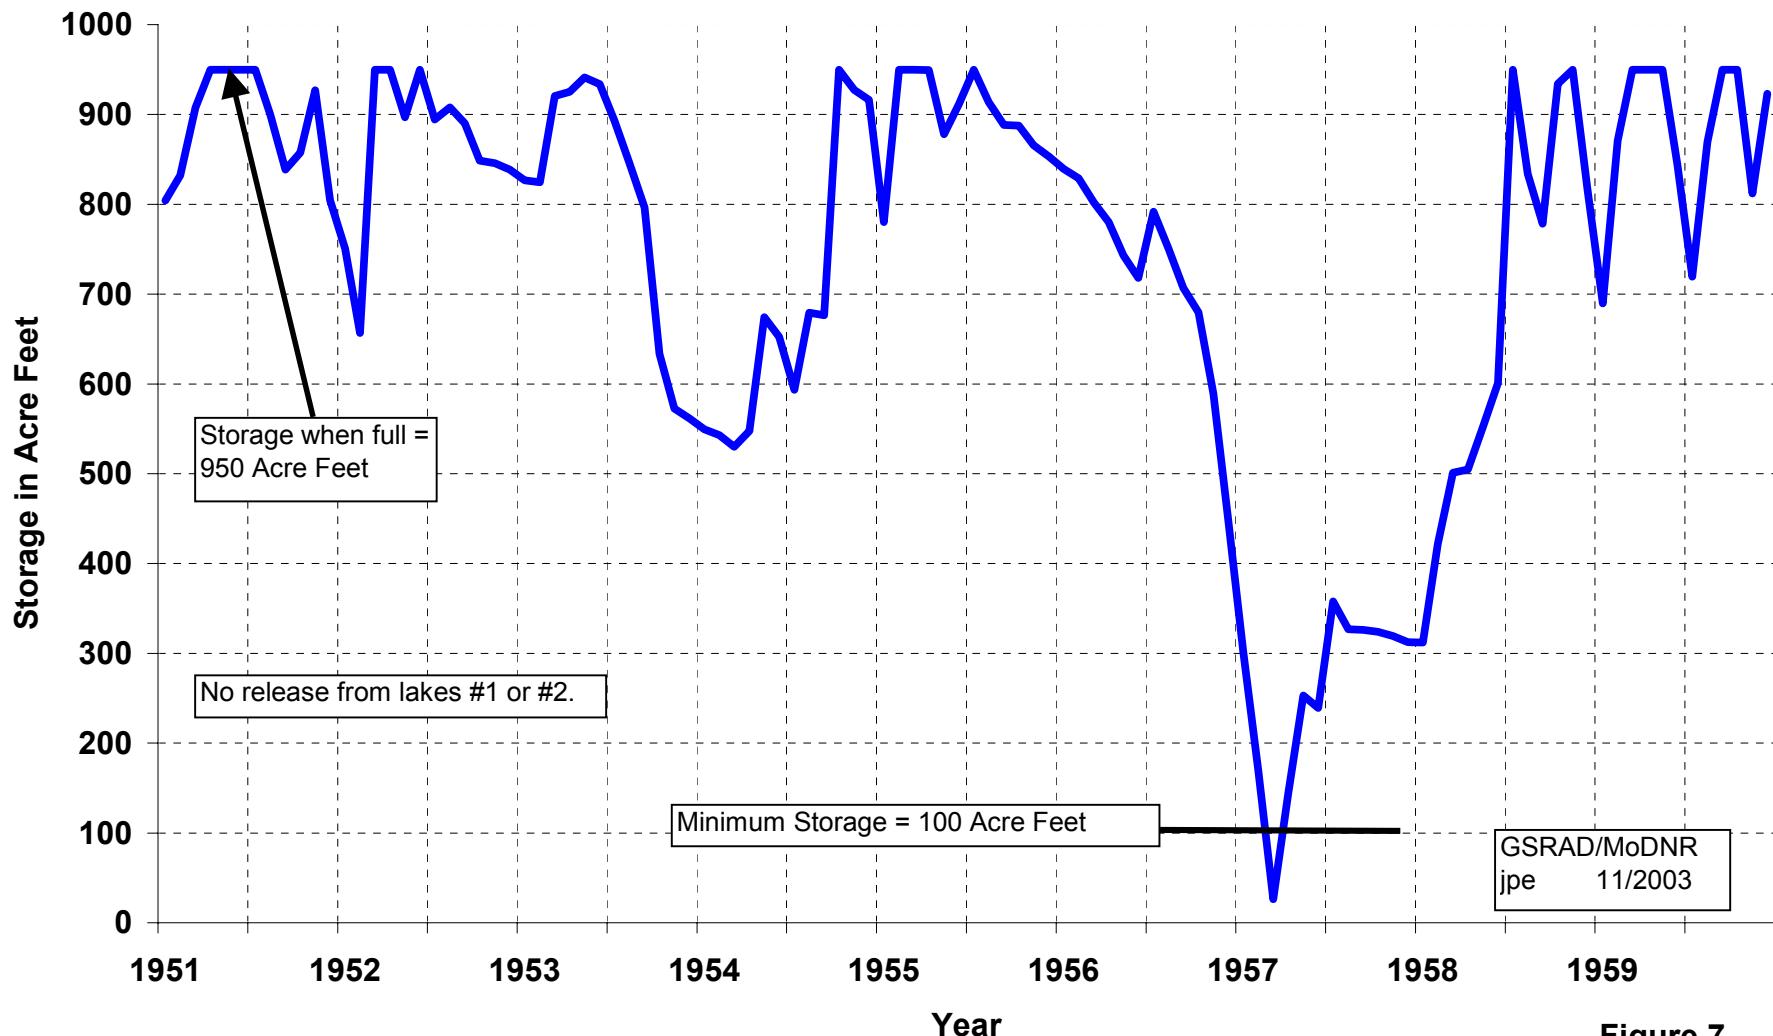
## Reservoir #3 Storage

Raise Elevation of Municipal Storage in GLM site 3 feet

Figure 7 is the analysis of lake #3 with a demand of 1.5 MGD and receiving the above listed water from the Grindstone Lake. No water was used from lakes #1 and #2. The result is the water level would drop below the 100 acre feet level that water could be safely taken for one month by about 70 acre feet. This amount of water could be taken from either lake #1 or #2. It could also be taken from Grindstone Lake sediment pool. The sediment pool has approximately 569 acre feet of storage. See File "lake #3 with GLM raised 3".
